Manhole Inspection Summary

Manhole # S45K__037MH

Insp Date: **4/29/08 12:00 AM**

Location Address: **1718 aliceanna st**

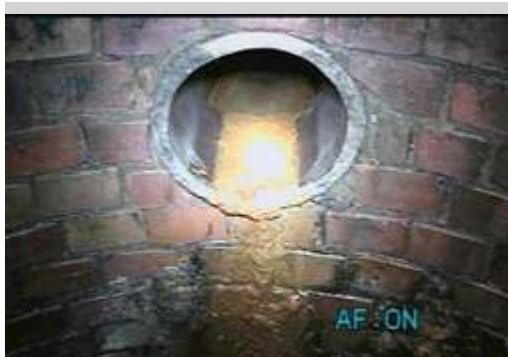
Defect 2

Infiltration: ☐ None ☐ Joint ☐ Cracks ☐ Mortar ☐ Roots ☒ **Wall**

Barrel Infiltration

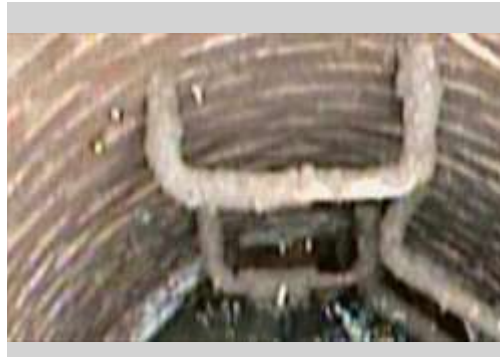
Defect 2

☒ **Evidence Of Surcharge** Depth: **5** (ft.) ☐ Active Surcharge Present

evidence of surcharge

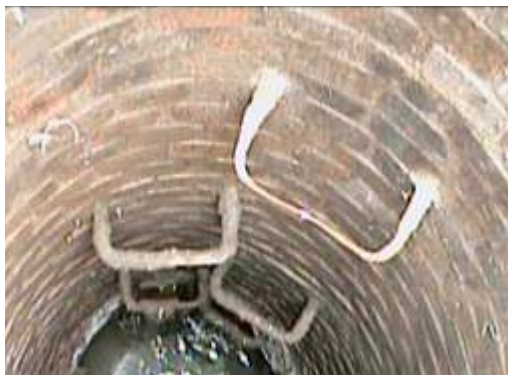
Defect 1

Count: **8** Missing: **2** ☒ **Corroded**

corroded steps; evidence of surcharge

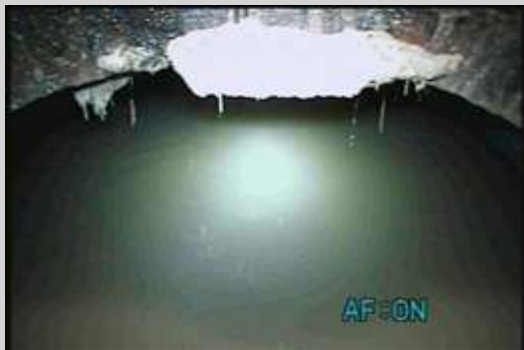
12 O'Clock Outflow

54 in. Circular Gravity Sewer
Pipe Out @ 12 O'Clock

Infiltration: **None** Pipe Seal Cond: **Unknown**

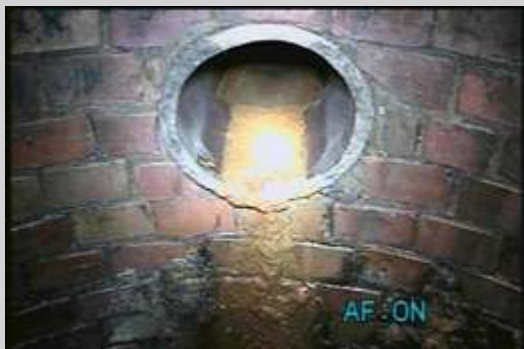
3 O'Clock Inflow

8 in. Circular Gravity Sewer
Pipe In @ 3 O'Clock

Infiltration: **None** Pipe Seal Cond: **Unknown**

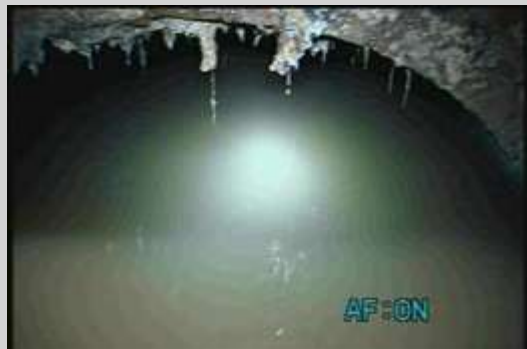
6 O'Clock Inflow

54 in. Circular Gravity Sewer
Pipe In @ 6 O'Clock

Infiltration: **None** Pipe Seal Cond: **Unknown**
